# LEVEL 2 REPLACEMENT RESERVE REPORT FY 2022 CARROLLSBURG SQUARE

# REPLACEMENT RESERVE REPORT

## CARROLLSBURG SQUARE

WASHINGTON, DISTRICT OF COLUMBIA  
May 19, 2023

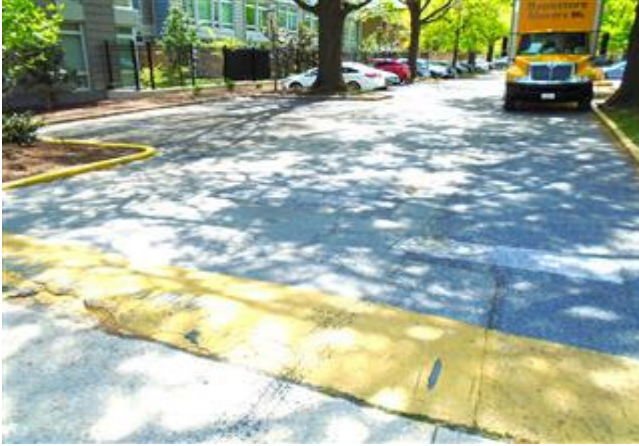
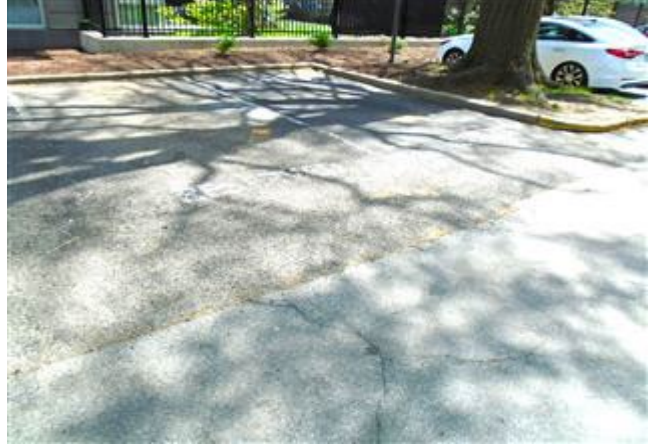
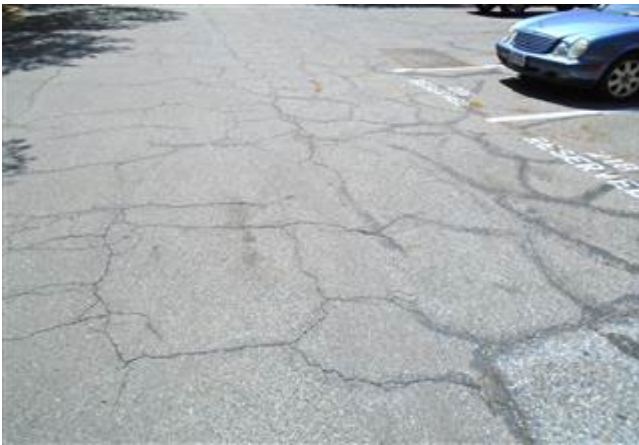
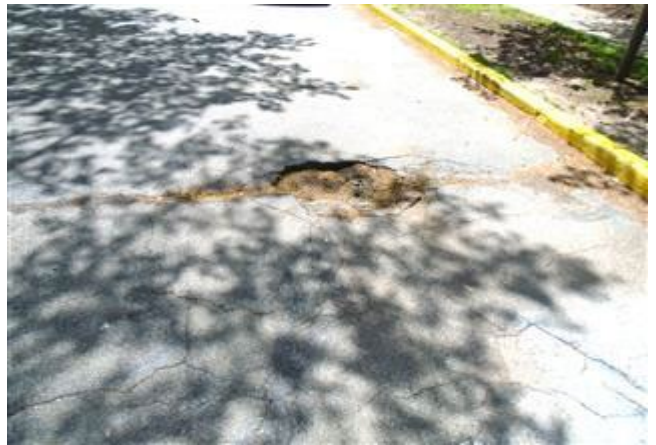
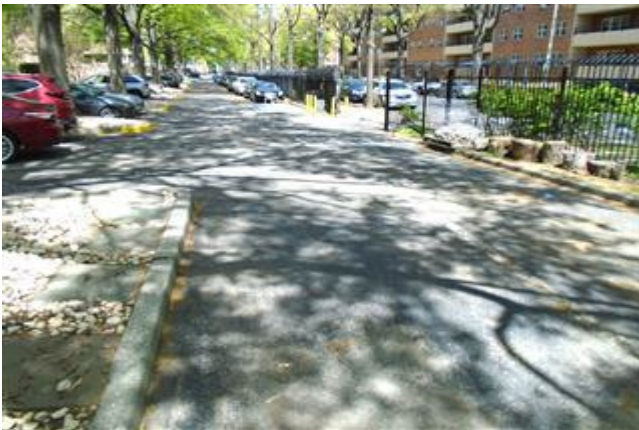
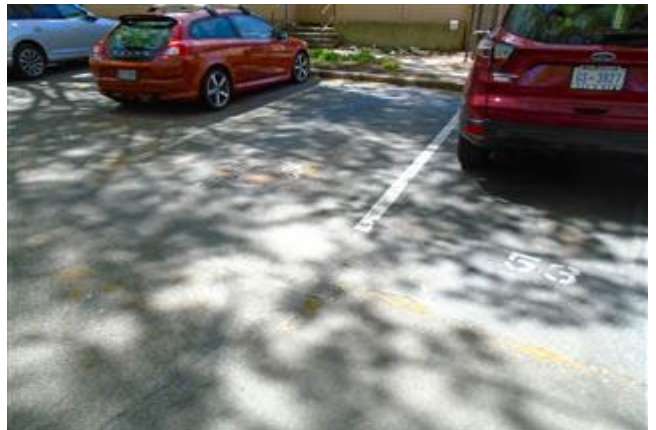
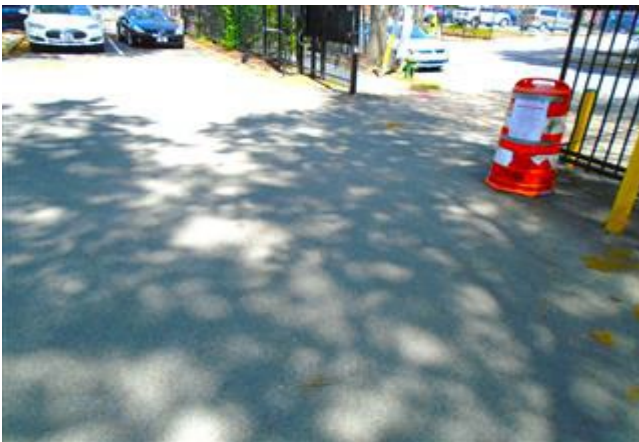
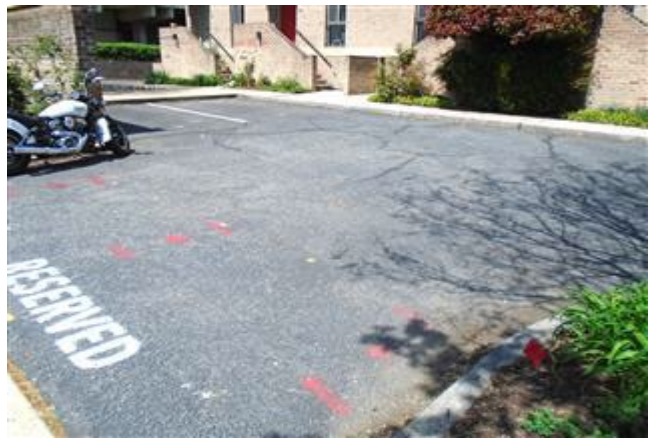
The pricing used is based on recent contracts for a two-inch overlay, which reflects the current local market for this work.

For seal coating, several different products are available. The older, more traditional seal coating product is paint. They coat the surface of the asphalt, and they are minimally effective. However, the newer coating materials, such as those from Total Asphalt Management, Asphalt Restoration Technologies, Inc., and others, are penetrating. They are engineered, so to speak, to 're-moisturize' the pavement. Asphalt pavement is intended to be flexible. Over time, the volatile chemicals in the pavement dry, the pavement becomes brittle, and degradation follows in the forms of cracking and potholes. Re-moisturizing the pavement can return its flexibility and extend its life of the pavement.

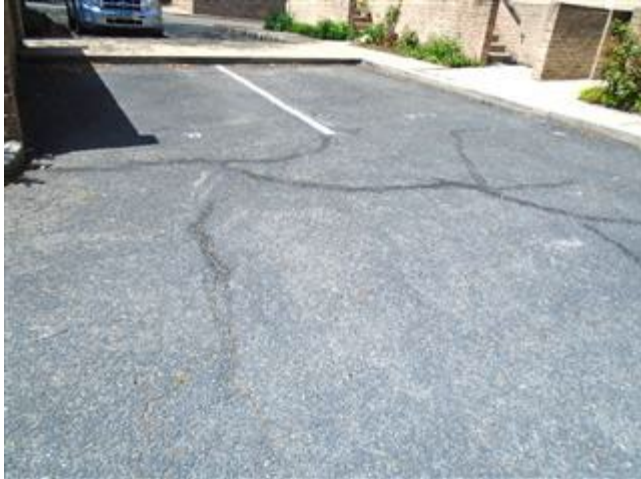
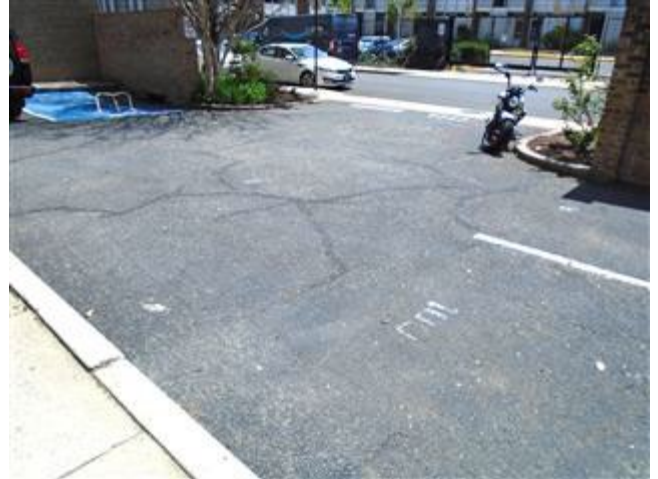
**Concrete Work.** The concrete work includes the community's curbing, sidewalk, lead walk, stoops, steps, and other concrete flatwork. The overall condition of the concrete work is good to fair. Multiple walkway areas were displaying cracking and lifting due to tree roots.

Because it is highly unlikely that all of the concrete components will fail and require replacement in the period of the study, we have programmed funds for the replacement of these inventories and spread the funds over an extended timeframe to reflect the incremental nature of this work.

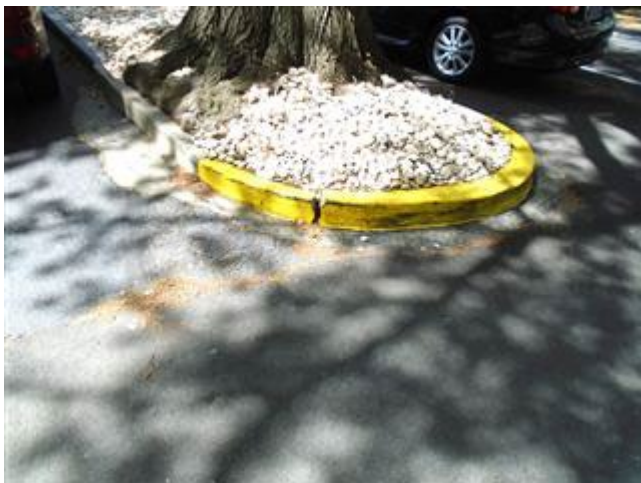
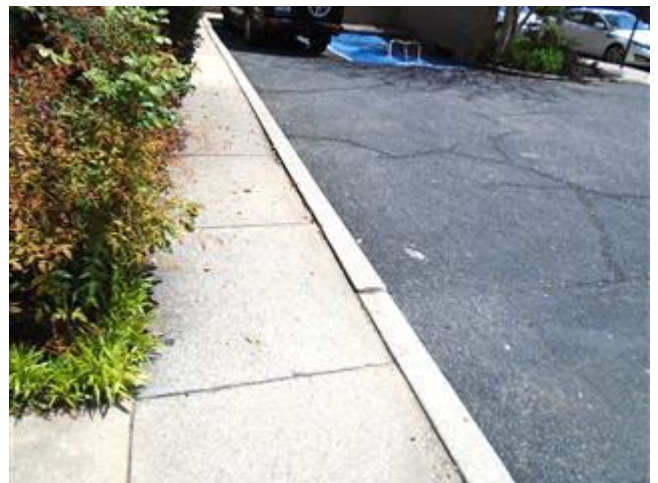
**Expansion Joint.** Expansion joints are composed of sacrificial, asphalt-impregnated fibrous material. This joint material should be installed between concrete elements to separate the curb, sidewalk, concrete drives, and other concrete components. The expansion joints should be installed at regular intervals during concrete replacement. Expansion joints allow for independent movement between adjoining structural members. Joints allow for thermal expansion and contraction without inducing stress in the system. Installing expansion joints in concrete permits independent horizontal and vertical movement between adjoining parts of the structure and helps minimize cracking. Expansion joints also mitigate the inflow of stormwater that undermines substrata and causes concrete to subside. The expansion joints should be inspected periodically and replaced as needed. The replacement of expansion joints is considered a maintenance function and therefore excluded from the reserve funding analysis.

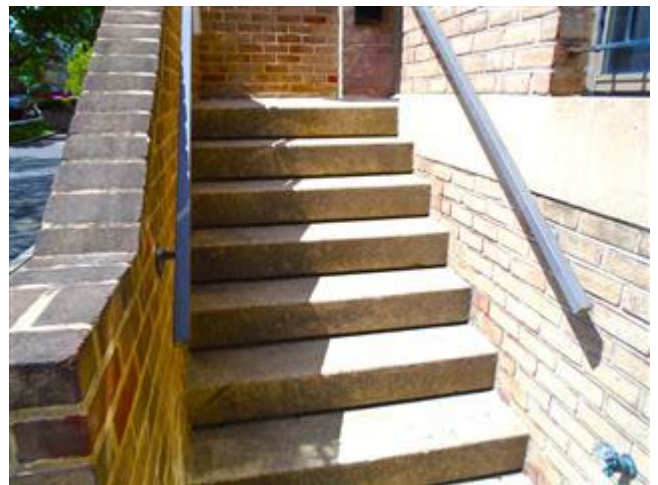
**Fencing.** The Association maintains perimeter and interior walkway aluminum picket fencing, metal hand railings, and pressure-treated lumber privacy fencing. The metal fencing and railings are in good overall condition. The wood privacy fencing is being replaced on an as-needed basis. The amount allocated for the wood privacy fencing is in accordance with the Association's historical expenditures.

Pressure-treated wood fencing should be cleaned and sealed every year or two. Typically the least cost fencing option, this type of fence can last 15 to 20 years if maintained properly.

- Lift or remove ornamental base covers, if applicable.
- Remove existing caulk completely.
- Clean, prime, and paint all posts.
- Apply an appropriate caulk around each post base.
- Tool and shape caulking to shed water from the post.
- Reinstall base covers, and seal and paint all joints.

Fence posts can have an extended useful life if these simple maintenance activities are performed. If left unattended, the pressure from expansive post rust can crack and damage the supporting material.

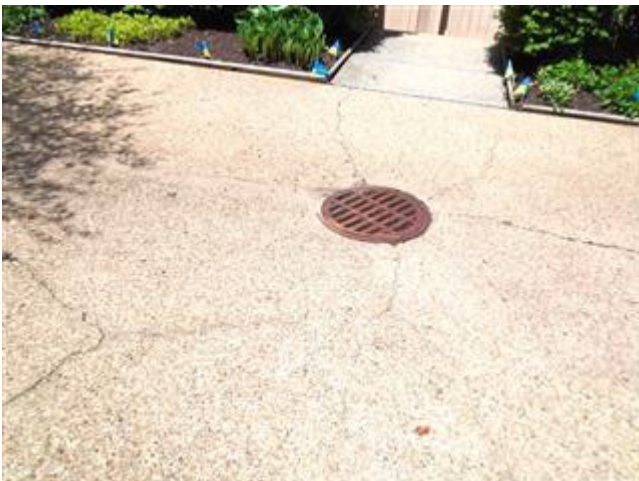
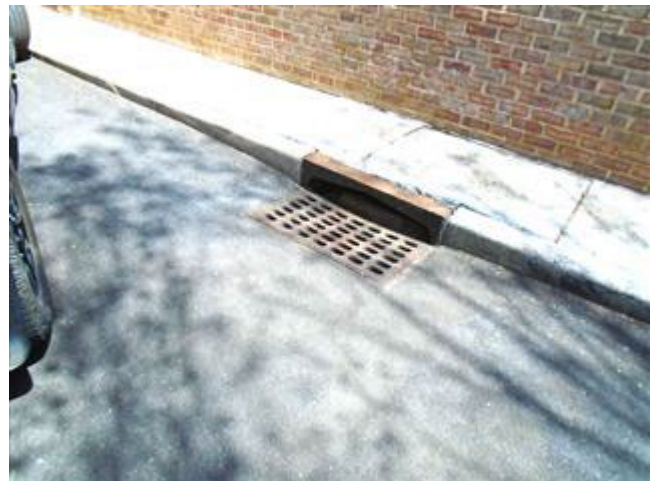
**Underground Utilities.** The Association is responsible for the underground utility line maintenance and replacement, including domestic water supply laterals, sanitary laterals, stormwater inlets, and piping roof drains to the stormwater system. The analyst was informed there have been minor problems with sanitary lines. 14 cut-off valves are serving the community. 13 have been replaced and one is scheduled for replacement in 2022.

*There were no engineering drawings provided for determining the location of the domestic water and sanitary lines. The lengths have been estimated. It is critical the Association determine the location of all underground piping to enable comprehensive inspection and efficient maintenance of the underground utilities.*

*Engineering drawings were not used in the determination of these underground components. Instead, we have provided an estimate of the approximate replacement costs based on our experience with other facilities of similar size and configuration. The inspection and evaluation of underground lines and structures are beyond the scope of work for this study.*

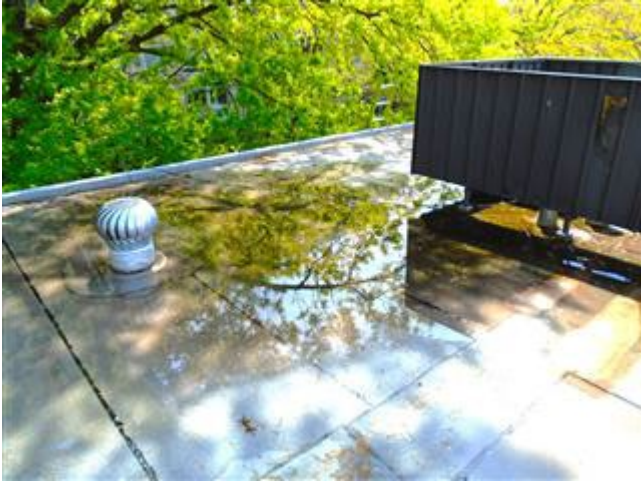
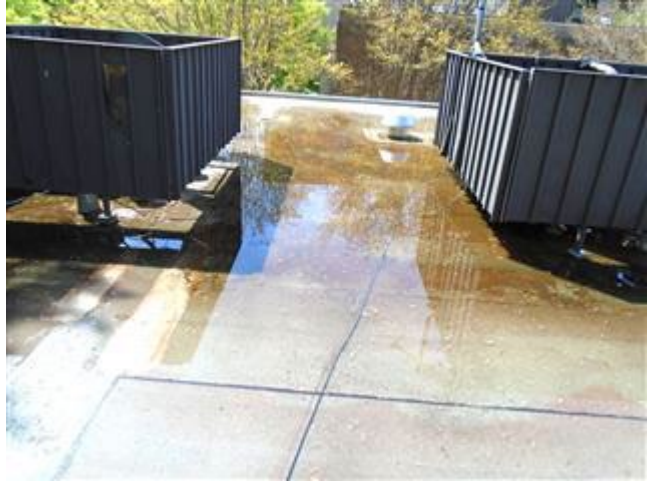
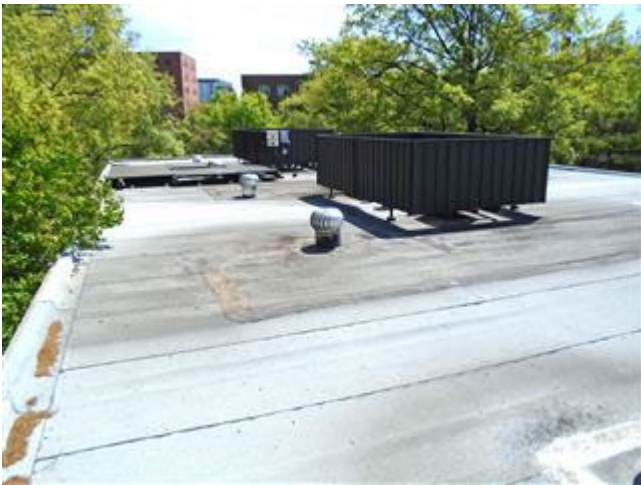
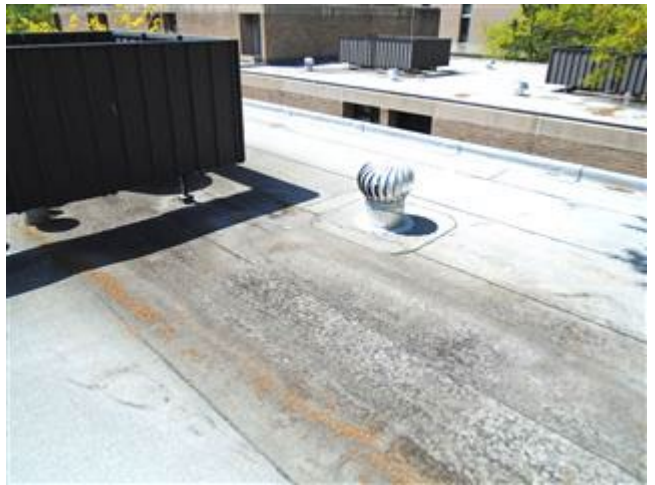
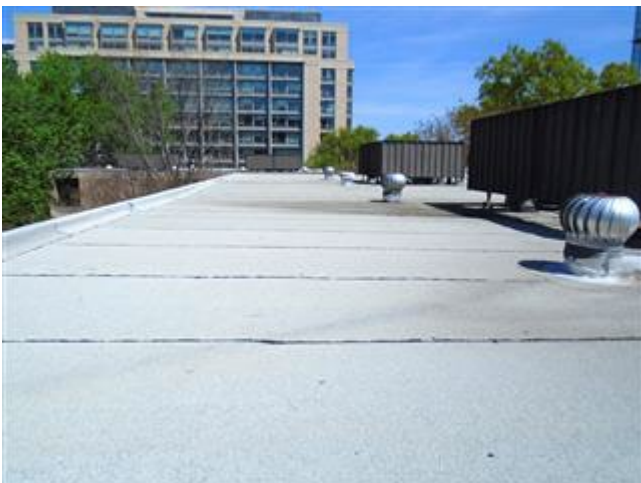
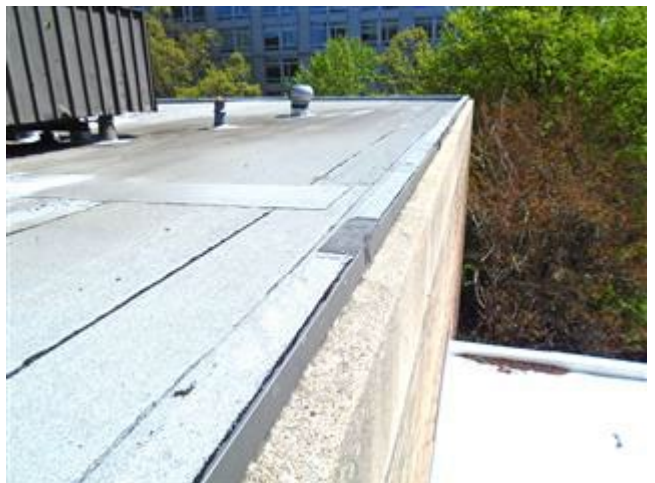
As with most rubbers, EPDM is always used compounded with fillers such as carbon black and calcium carbonate, with plasticizers such as paraffinic oils, and has useful rubbery properties only when cross-linked. Cross-linking mostly takes place via vulcanization with Sulfur but is also accomplished with peroxides (for better heat resistance) or with phenolic resins.

Minimally, bi-annual inspections are recommended, with cleaning, repair, and mitigation of vegetation performed as needed. Access, inspection, and repair work should be performed by contractors and personnel with the appropriate access equipment who are experienced in the types of roofing used for the facility.

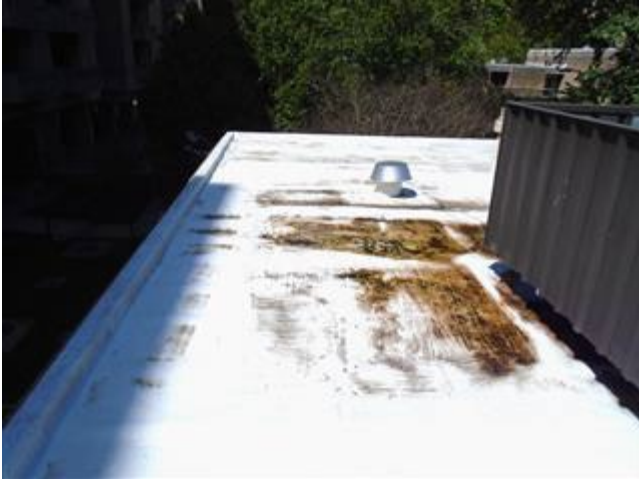
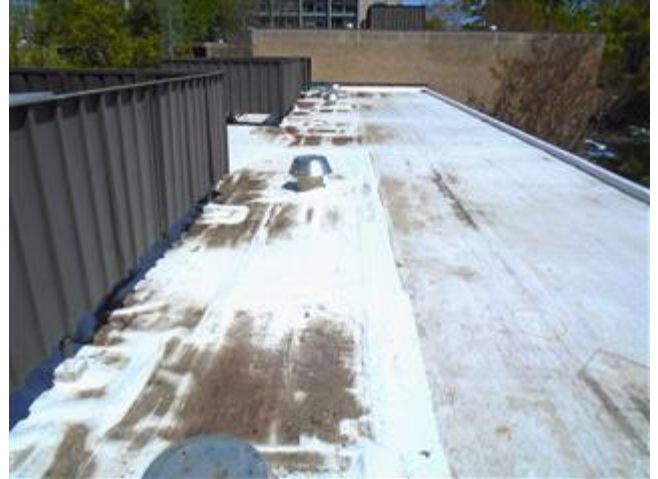
**Ventilation Fans.** Unit exhaust ventilation is provided by a series of rooftop non-mechanized fan units. An allowance for a replacement for a percentage of the fans on a cyclical basis has been programmed in the analysis.

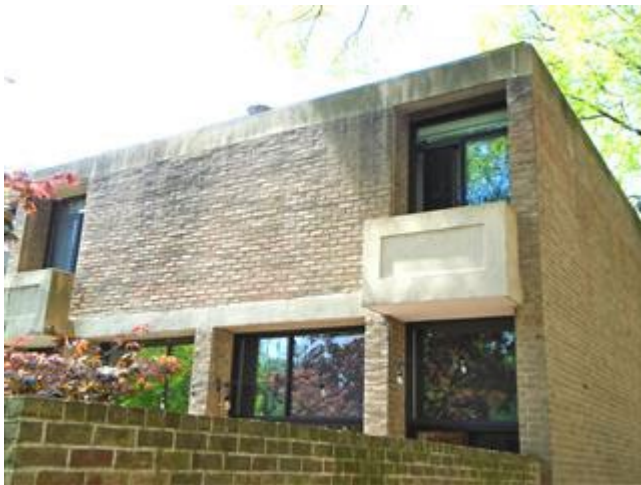
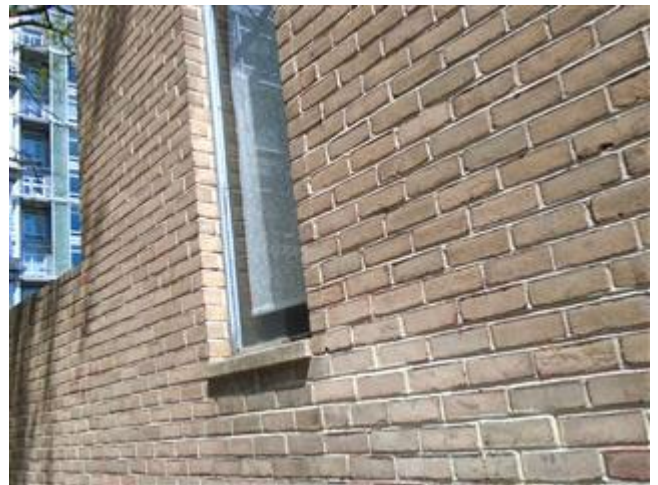
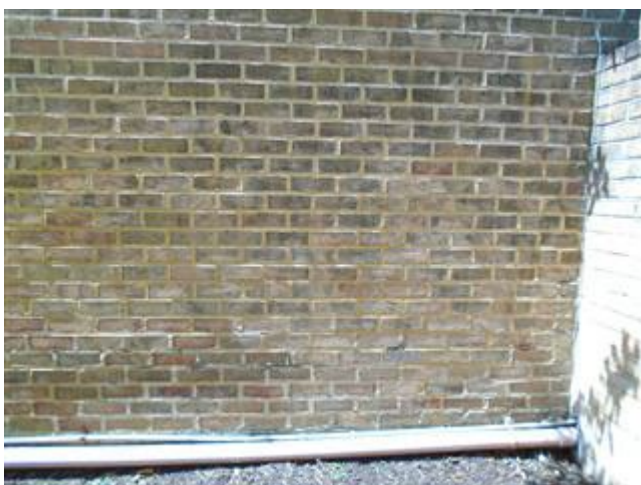
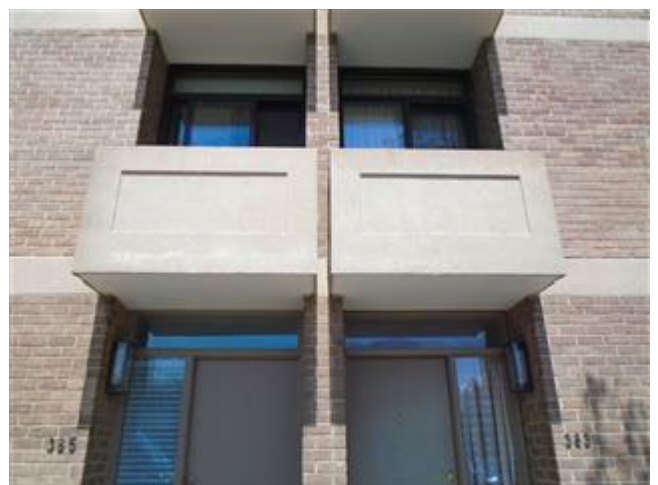
**Masonry.** Brick masonry is used as the exterior cladding on the buildings. The prior study estimated the exterior brick area to be approximately 50,000 sf. In general, masonry is considered a long-life item, and therefore full-scale replacement has been excluded from reserve funding. However, as masonry weathers, the mortar joints will become damaged by water penetration. As additional water gains access to the joints, repeated freeze-thaw cycles gradually increase the damage to the mortar joints. If allowed to progress, even brick and stone can have their surfaces affected and masonry units can become loose.

Brick walls can have an extended useful life of 100 years or more and will require periodic re-pointing and localized repair. Repoint is the process of raking out defective masonry joints and tooling a new mortar into the joints. Properly mortared and tooled joints will repel the weather and keep water from penetrating the wall. Siloxane or other breathable sealants provide additional protection to the wall from water penetration.

The terms pointing, re-pointing, and tuckpointing are used interchangeably. The Brick Industry Association has identified the terms 're-pointing' and 'tuck-pointing' methods as one form of brick masonry maintenance. A critical step in the re-pointing operation is to identify all areas that require re-pointing. This step is critical because only defective joints require repair. Re-pointing is very labor-intensive work, and original mortar joints in good condition are preferred over new.

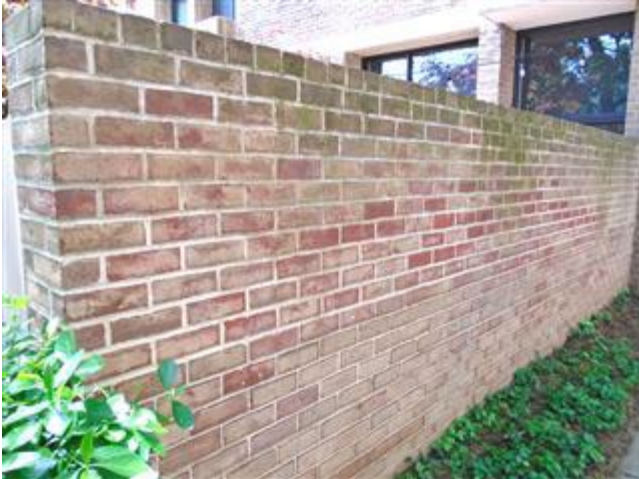
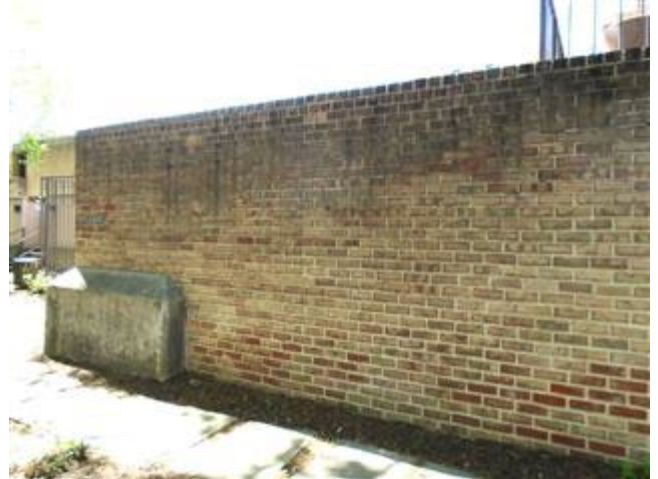
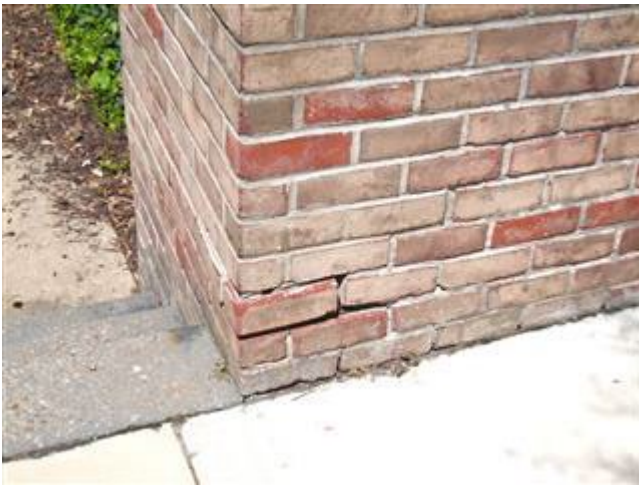
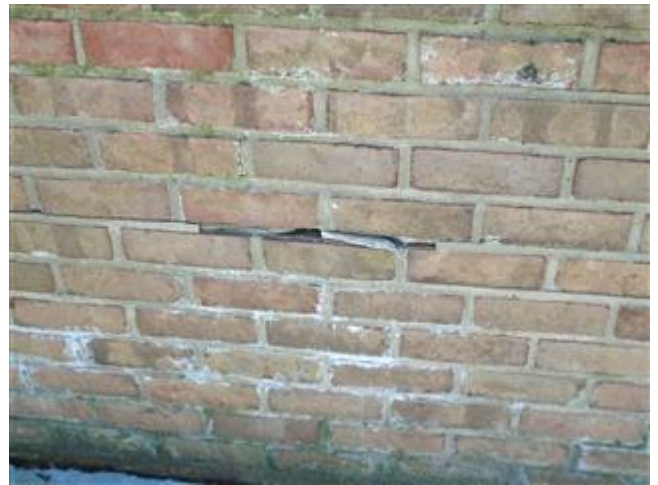
**Brick Privacy Walls.** In addition to unit brick exterior walls, the Association maintains brick privacy walls. These walls surround unit courtyards and can be affected by tree growth and are independent of unit structures. There were a limited number of privacy walls displaying damage. The wall should be periodically inspected and a comprehensive plan for repairs developed. An allowance for brick privacy wall repair and maintenance has been programmed in the analysis.

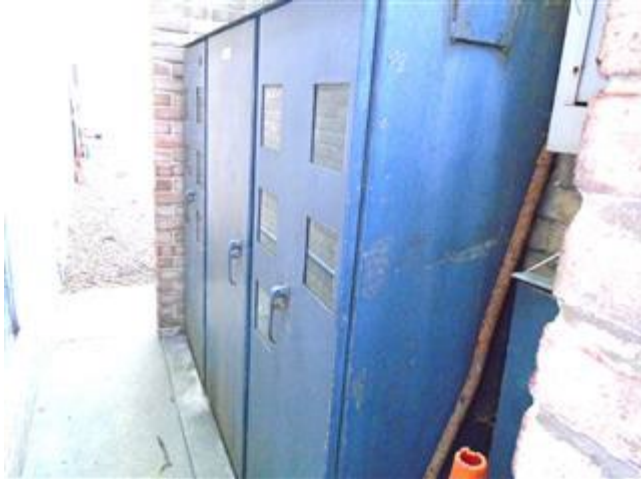
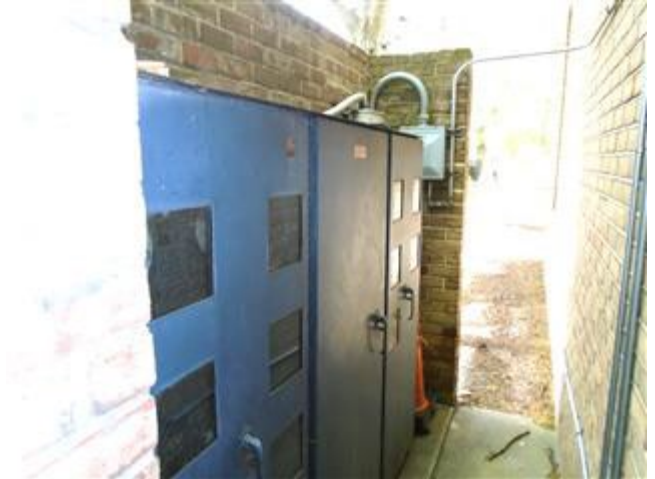
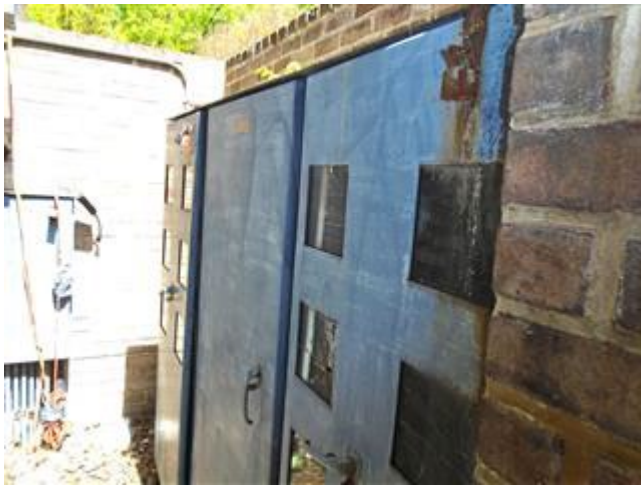
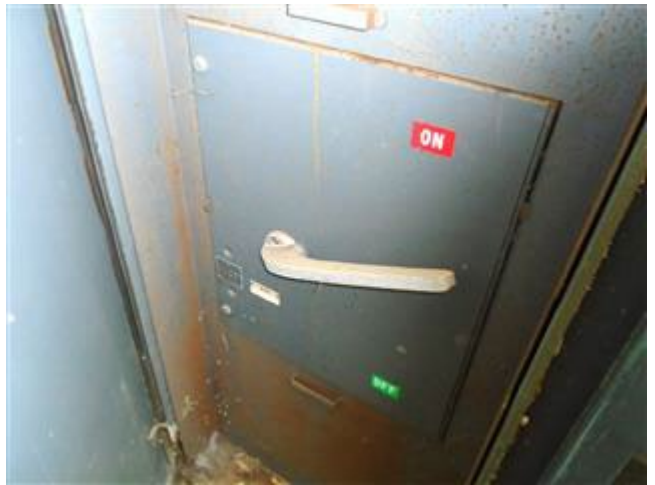
**Building Electrical Service.** The electrical systems of the buildings are reported to be operating normally. The individual unit meters have been updated.

The overall condition of the switchgear appears to be good. As the switchgear continues to age, obtaining replacement parts can be expected to become more difficult. When parts are no longer available or when the condition of the switchgear deteriorates sufficiently, the Association will have to replace or upgrade the existing equipment. Therefore, we have included funding in the Reserve Analysis for switch replacement.
